DYNAMIC FULL SCALE TESTS
OF
MEDIAN BARRIERS

John L. Beaton

Robert N. Field

Presented at the 39th Annual Meeting of the
Highway Research Board, Washington, D. C.
January 11-15, 1960

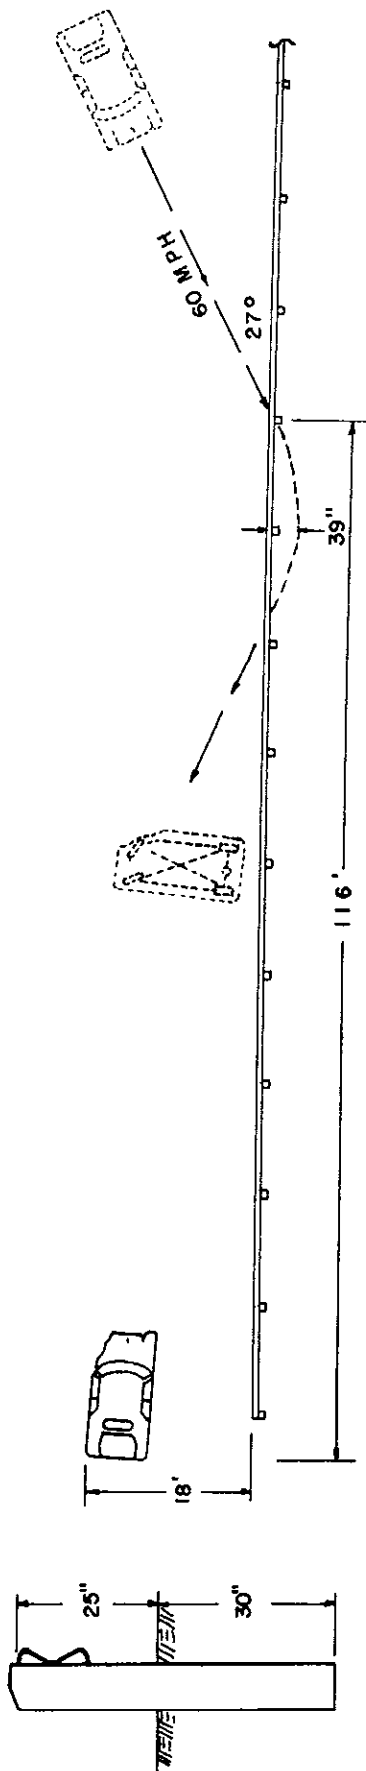
GUARDRAIL	W Section	DUMMY INJURY	Left shoulder & side injuries. Possible concussion.	TEST NO.	1
BRACKET	None	GUARDRAIL DAMAGE	3 Sections damaged beyond repair.	DATE	7-10-58
POST	8x8 D.F.	POST DAMAGE	2 Posts damaged beyond repair.	VEHICLE	Chev. 52 Sedan
POST SPACING	12'-6" O.C.	VEHICLE DAMAGE	12 Posts out of alignment.	SPEED	60 MPH
LENGTH OF INSTALLATION	212.5'	MAX. DYNAMIC DEFLECTION OF RAIL	48"	IMPACT ANGLE	27°
GROUND CONDITION	Dry			VEHICLE WEIGHT ...	3980
				(W/DUMMY & INSTRUMENTATION)

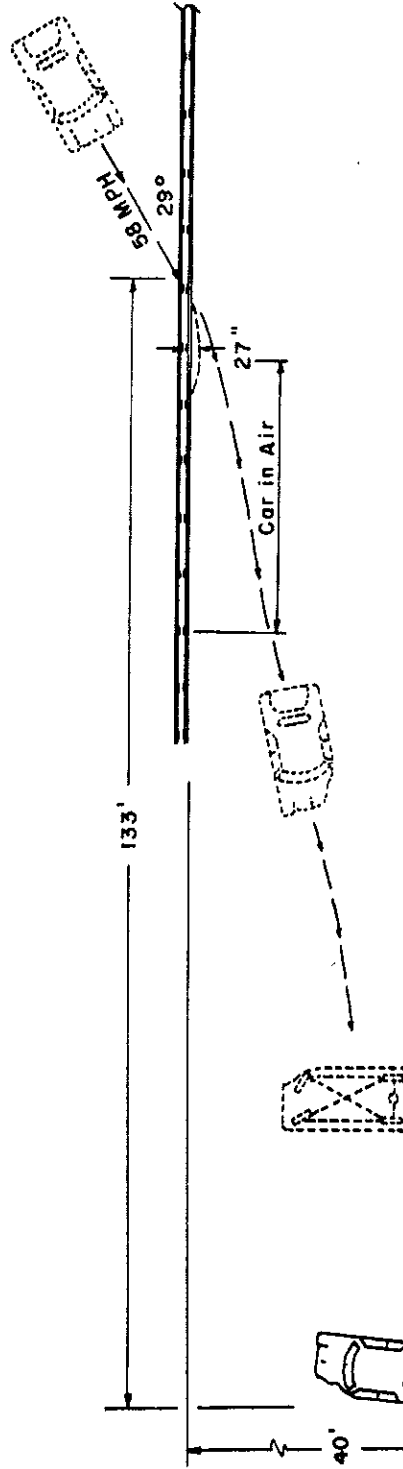
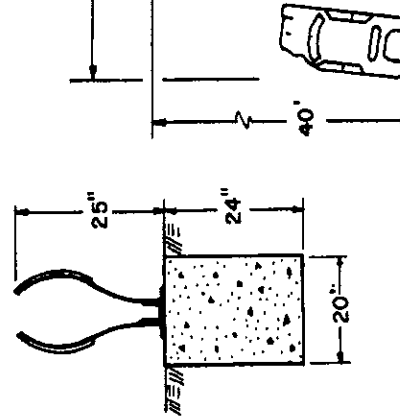
GUARDRAIL	Tutthill	DUMMY INJURY	Left shoulder & side injuries. Possible concussion.	TEST NO.	3
BRACKET	HG 26N	GUARDRAIL DAMAGE	4 Sections damaged beyond repair.	DATE	8-6-58
POST	HG26N	POST DAMAGE	Inside rail failed.	VEHICLE	Chev. 53 Sedan
POST SPACING	6'-3" O.C.	POST DAMAGE	6 Brackets damaged beyond repair.	SPEED	58 MPH
LENGTH OF INSTALLATION	100'	VEHICLE DAMAGE	Total loss	IMPACT ANGLE	29°
GROUND CONDITION	Dry	MAX. DYNAMIC DEFLECTION OF RAIL	27" Before failure.	VEHICLE WEIGHT	3980
					(W/DUMMY & INSTRUMENTATION)

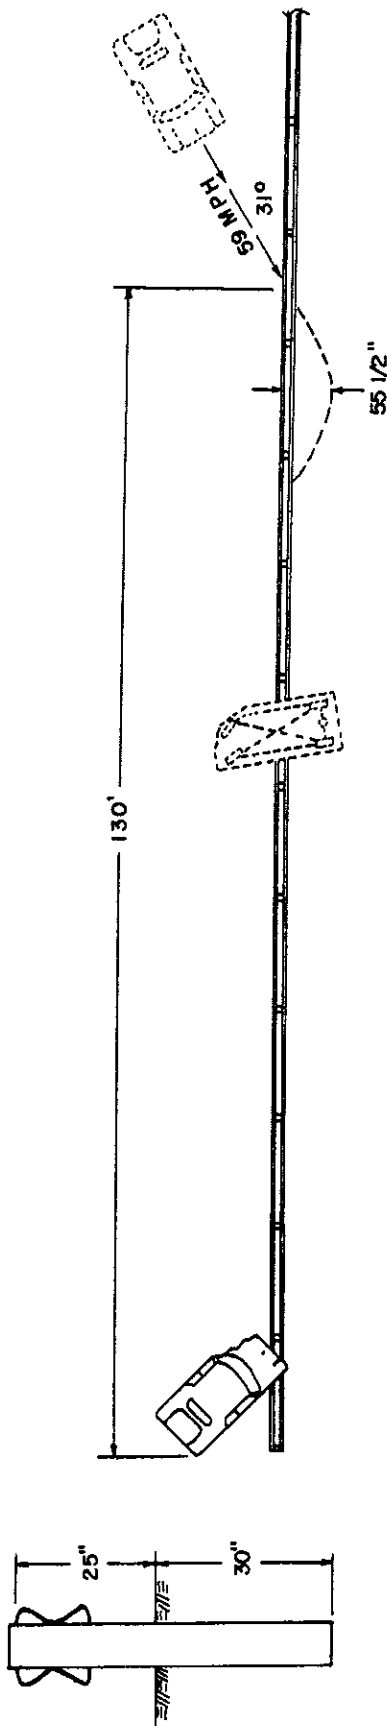
TEST NO. 4
 DATE 8-20-58
 VEHICLE Chev. 51 Sedan
 SPEED 59 MPH
 IMPACT ANGLE 31°
 VEHICLE WEIGHT... 3980
 (W/DUMMY & INSTRUMENTATION)

GUARDRAIL W Section
 BRACKET None
 POST 8x8 D.F.
 POST SPACING 12'-6" O.C.
 LENGTH OF INSTALLATION... 200'
 GROUND CONDITION Dry

DUMMY INJURY Severe neck, head & left shoulder injuries.
 GUARDRAIL DAMAGE 3 Sections damaged beyond repair.
 POST DAMAGE 1 Post damaged beyond repair.
 VEHICLE DAMAGE 7 Posts out of alignment.
 MAX. DYNAMIC DEFLECTION OF RAIL... 60" Total loss.

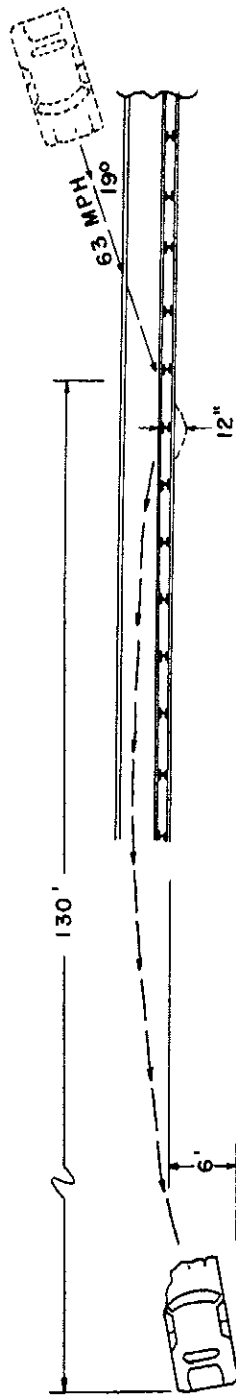
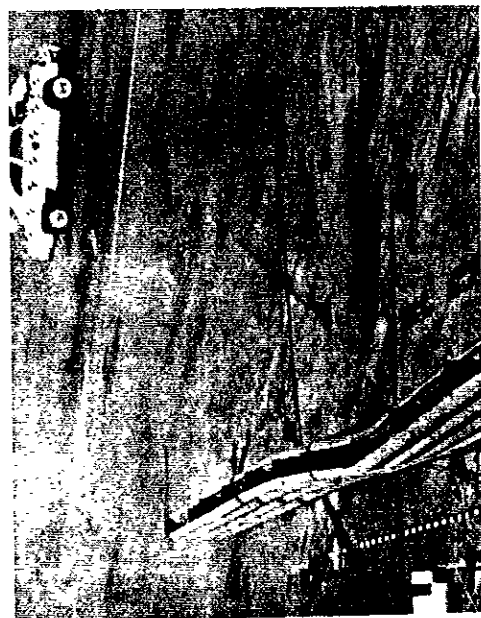
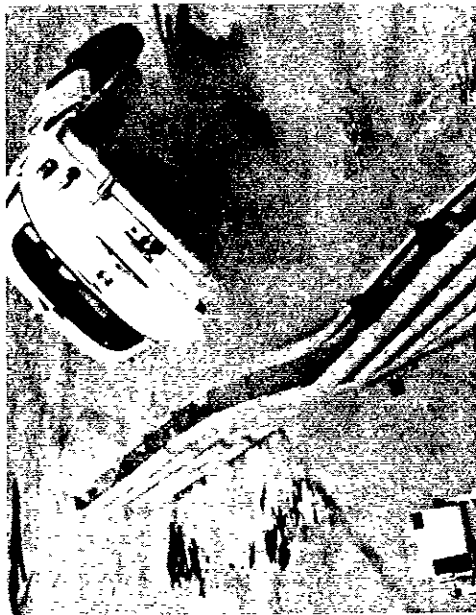
TEST NO. 7
DATE 9-18-58
VEHICLE Chev. 54 Sedan
SPEED 63 M P H
IMPACT ANGLE 19°
VEHICLE WEIGHT...4050
(W/DUMMY & INSTRUMENTATION)

GUARDRAIL Tuthill
BRACKET HG 32 N
POST 6" WF 15.5 #
POST SPACING 6'-3" O.C.
LENGTH OF INSTALLATION...100'
GROUND CONDITION Dry

DUMMY INJURY Severe head, chest & internal injuries.
GUARDRAIL DAMAGE 2 Sections damaged beyond repair.
POST DAMAGE 2 Posts damaged beyond repair.
VEHICLE DAMAGE 2 Posts out of alignment.
MAX. DYNAMIC DEFLECTION OF RAIL...19" Total loss.

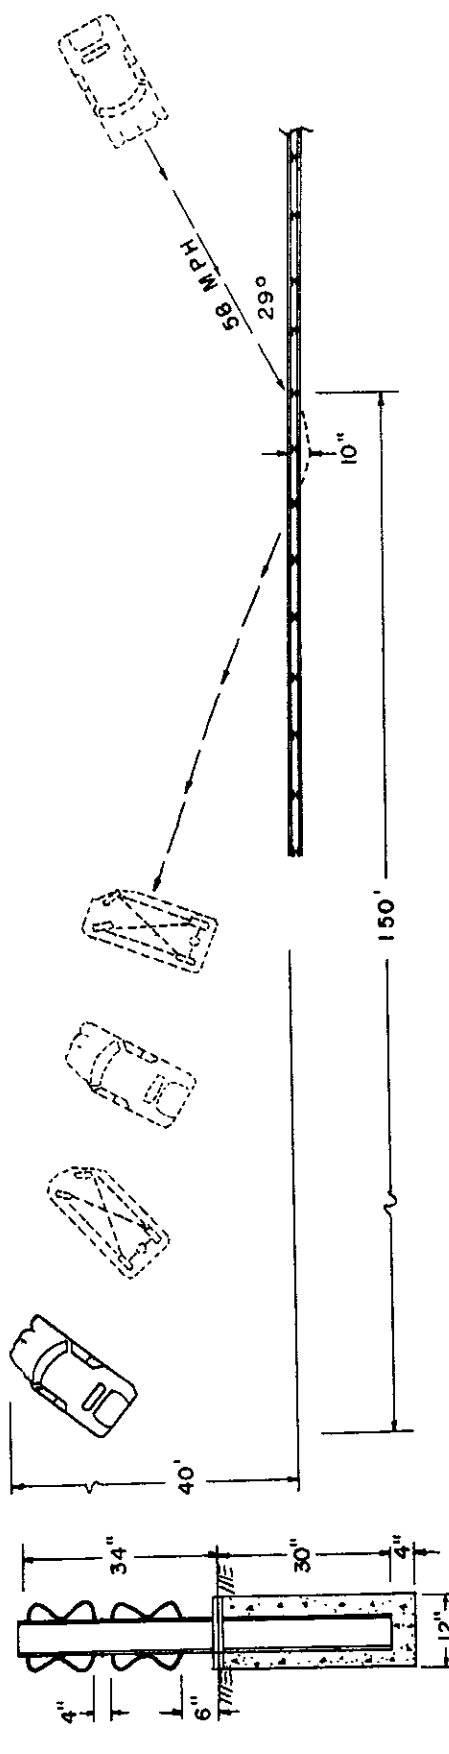
TEST NO 8
 DATE 10-2-58
 VEHICLE Chev. 52 Sedan
 SPEED 58 M.P.H.
 IMPACT ANGLE 29°
 VEHICLE WEIGHT... 4050
 (W/DUMMY & INSTRUMENTATION)

GUARDRAIL W Section
 BRACKET None
 POST 6" W 15.5 #
 POST SPACING 6'-3" O.C.
 LENGTH OF INSTALLATION ... 100'
 GROUND CONDITION Dry

DUMMY INJURY Severe head, shoulder & arm injuries.
 GUARDRAIL DAMAGE Multiple lacerations & concussion.
 POST DAMAGE 2 Sections damaged beyond repair.
 VEHICLE DAMAGE All can be repaired.
 MAX. DYNAMIC DEFLECTION OF RAIL... 15"

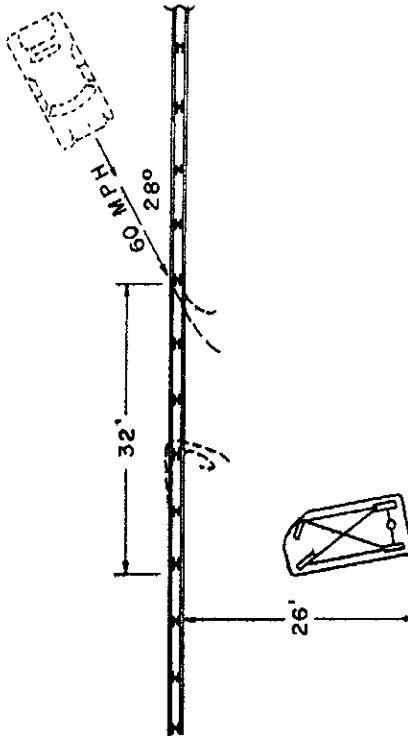
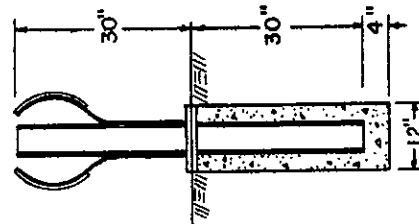
There has been some belief that a spring system for mounting a guard rail would tend to minimize damage to the offending car. It may be true under light collisions; however, under heavy collisions as presented by Test No. 9 (Exhibit 10), a flexible mounting tends to allow the rail to pocket between the posts. This results in a rail failure and the car passing on through the railing, thus it has little value as a positive barrier.

GUARDRAIL	Tutthill	DUMMY INJURY	Head, neck, chest & possible internal injuries.	TEST NO.	9
BRACKET	HG15N	GUARDRAIL DAMAGE	4 Sections damaged beyond repair.	DATE	10-15-58
POST	6" W 15.5 #		Both rails failed.	VEHICLE	Chev 54 Sedan
POST SPACING	6'-3" O.C.	POST DAMAGE	2 Posts damaged beyond repair.	SPEED	60 MPH
LENGTH OF INSTALLATION	100'		2 Posts out of alignment.	IMPACT ANGLE	28°
GROUND CONDITION	Dry	VEHICLE DAMAGE	Total loss.	VEHICLE WEIGHT	3970
		MAX. DYNAMIC DEFLECTION OF RAIL	15" Before failure.	(W/DUMMY & INSTRUMENTATION)

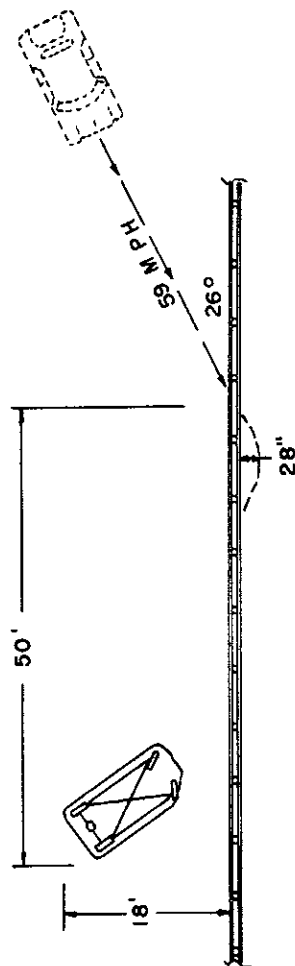
TEST NO. II
DATE 10-30-58
VEHICLE Ford 55 Sedan
SPEED 59 MPH
IMPACT ANGLE 26°
VEHICLE WEIGHT ... 4050
(W/DUMMY & INSTRUMENTATION)

DUMMY INJURY	Left shoulder & side, chest & internal injuries.
GUARDRAIL DAMAGE	6 Sections damaged beyond repair.
POST DAMAGE	3 Posts damaged beyond repair.
	3 Posts out of alignment.
VEHICLE DAMAGE	Total loss.
MAX. DYNAMIC DEFLECTION OF RAIL...40"

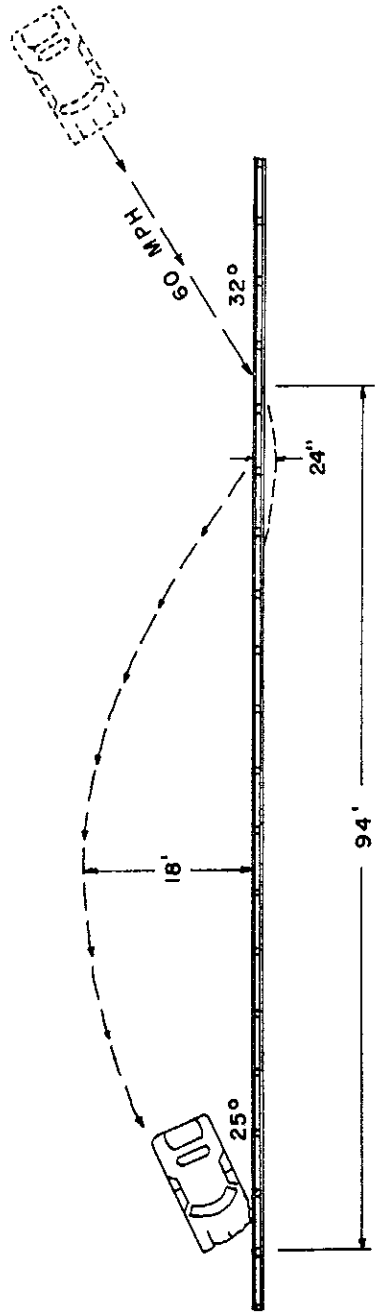
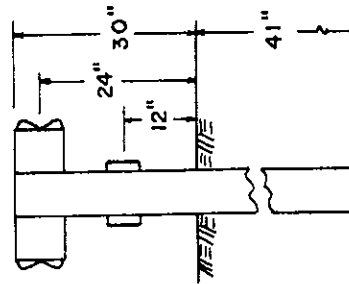
GUARDRAIL	W Section	DUMMY INJURY	Possible left shoulder, arm & side injuries.	TEST NO.	13
CHANNEL	6" 8.2 #	GUARDRAIL DAMAGE	4 Sections damaged beyond repair.	DATE	12-18-58
BRACKET	8x8x12 D.F. Block	CHANNEL DAMAGE	4 Sections damaged beyond repair.	VEHICLE	Chev. 53 Sedan
POST	8x8 D.F.	POST DAMAGE	3 Posts damaged beyond repair.	SPEED	60 MPH
POST SPACING	6'-3" O.C.	VEHICLE DAMAGE	900	IMPACT ANGLE	32°
LENGTH OF INSTALLATION	125'	MAX. DYNAMIC DEFLECTION OF RAIL	37"	VEHICLE WEIGHT	4000
GROUND CONDITION	Dry	VEHICLE DECELERATION (PEAK)	Long. 104 G... Transv. 198 G	(W/DUMMY & INSTRUMENTATION)	
		DUMMY DECELERATION (PEAK)	Long. 16 G... Transv. 18 G

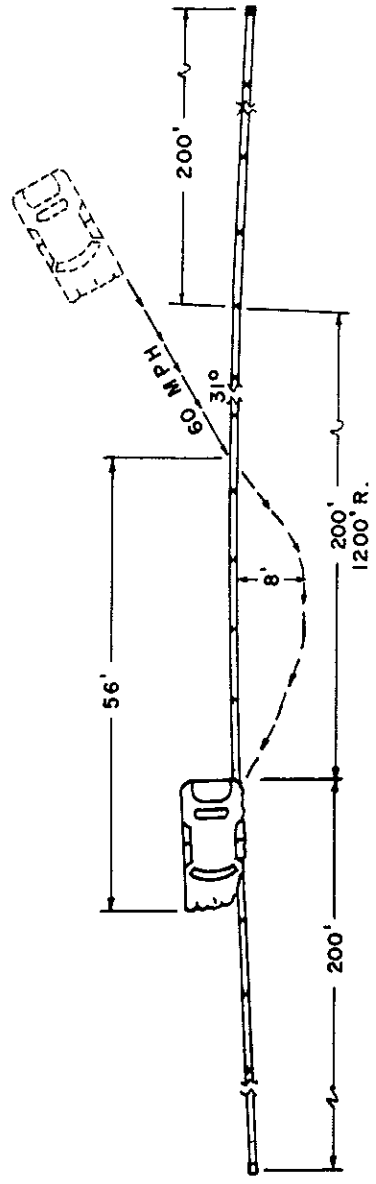
TEST NO. 21
DATE 3-20-59
VEHICLE Chev. 53 Sedan
SPEED 60 MPH
IMPACT ANGLE ... 31°
VEHICLE WEIGHT ... 3850
(W/ DUMMY & INSTRUMENTATION)

GUARDRAIL 36" Chain Link
Fence w/ 2 3/4" cables 9" & 30" above pvt.
POST 2 1/4" - 4.1 #
H Section Fence Post.
POST SPACING 8' O.C.
LENGTH OF INSTALLATION... 600'
GROUND CONDITION Wet

DUMMY INJURY Scalp laceration, possible chest injuries.
GUARDRAIL DAMAGE 56' of fence knocked out. No damage to cables.
POST DAMAGE 12 posts damaged beyond repair.
VEHICLE DAMAGE Total loss.
MAX. DYNAMIC DEFLECTION OF RAIL ... 8'
VEHICLE DECELERATION (PEAK) ... Long. NG ... Transv. NG
DUMMY DECELERATION (PEAK) Long. 6G ... Transv. 4G

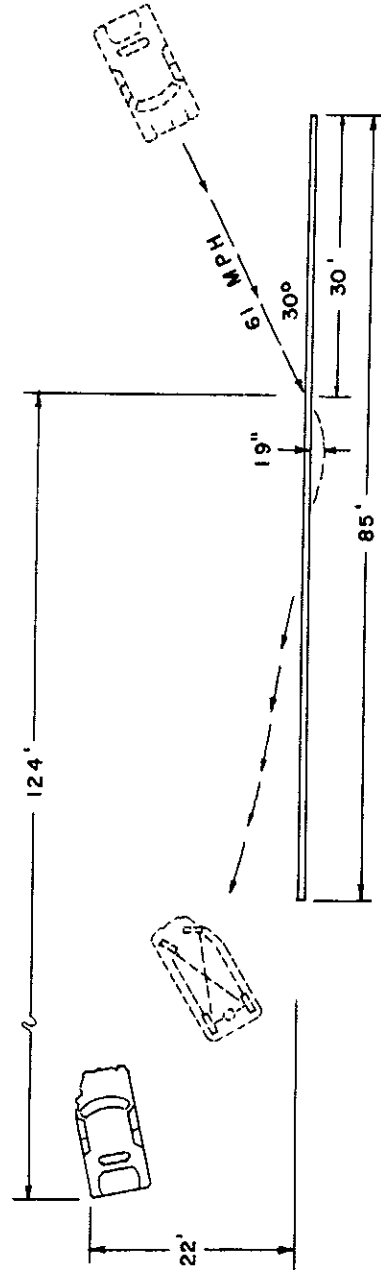
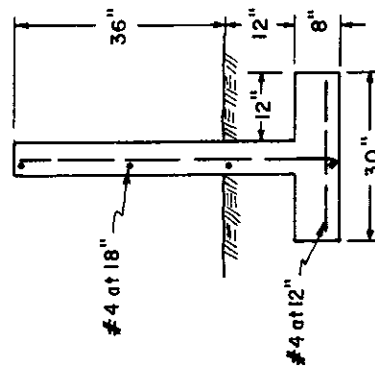
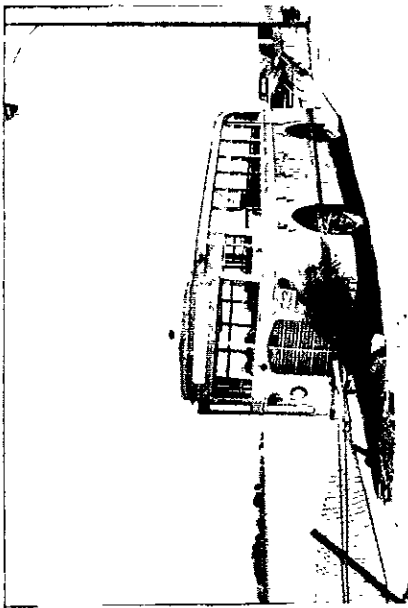
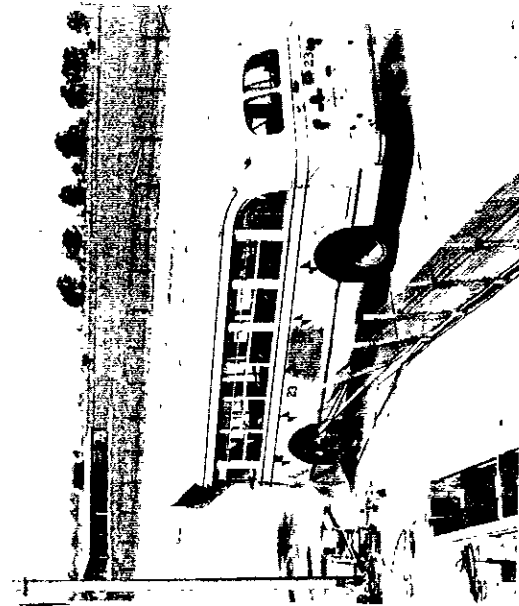
Rigid barriers are represented in this series by only one test, Exhibit 19, but this test was supplemented by information gained during dynamic tests of five bridge rails performed and reported in 1955 and two concrete bridge rails tested during this series. As shown by the test data sheet, this design failed during tests.

Indications from the results of Test No. 22 (Exhibit 19) are that the design of this rail needs only a slight amount of stiffening to make it serve under heavy collisions. Previous tests on bridge rails indicate that a wall as low as 27" in height could be effective as long as it did not fail. The reflective action from a properly designed concrete wall as indicated by previous tests conducted on bridge rails shows that the offending vehicle will reflect from the concrete wall with an abrupt change in direction and with high decelerations caused by the extremely rapid reflection of the vehicle from the non-deflecting surface. There is good opportunity, however, for evasive action by following cars in that the reflection angle is normally flat and due to the damaged colliding wheel the car tends to curve back into the rail and come to rest against it. There is even less opportunity of evading stalled traffic ahead after collision than there is with the semi-rigid type of barrier.

The failure of the light concrete wall used in Test No. 22 served to illustrate again the fact that when a rail "lays over" during a heavy collision, no matter what the height, a high speed colliding vehicle will tend to roll after reflecting from the barrier. Thus it is evident that any barrier design in which it is expected that measurable downward deflection will take place, then provision must be made to hold the restraining unit (rail, cable, etc.) at or above the center of gravity of the vehicle at the first instant of and throughout collision.

GUARDRAIL	36" Conc.	DUMMY INJURY	Concussion, severe shoulder & chest injuries.	TEST NO.	22
Wall, 6" Thick.		GUARDRAIL DAMAGE	20' Wall broken	DATE	3-30-59
REINFORCING BAR SPACING..	#4 at 12" Vert.	VEHICLE DAMAGE	Total loss	VEHICLE	Chev. 53 Sedan
	#4 at 18" Horiz.	MAX. DYNAMIC DEFLECTION OF RAIL..	22"	SPEED	61 MPH
LENGTH OF INSTALLATION...	85'	VEHICLE DECELERATION (PEAK)	Long. 112G... Transv. 72G	IMPACT ANGLE ...	30°
GROUND CONDITION	Wet	DUMMY DECELERATION (PEAK)	Long. 21G... Transv. 25G	VEHICLE WEIGHT ...	3850
				(W/DUMMY & INSTRUMENTATION)

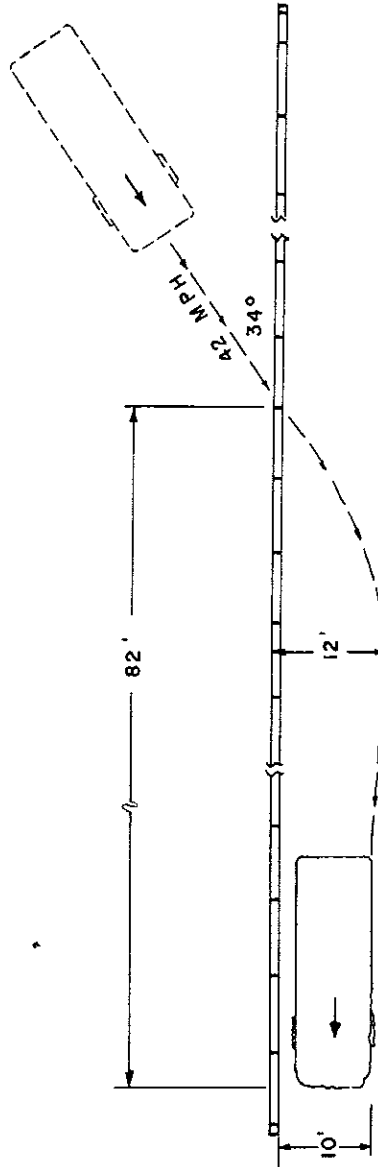
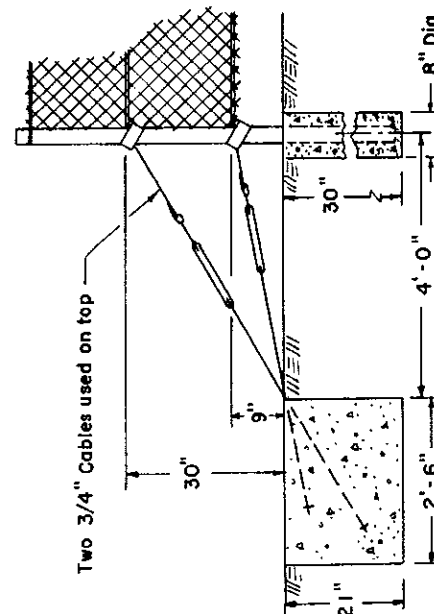
TEST NO. 23
DATE 4-21-59
VEHICLE 1937-40 pass. Bus
SPEED 42 MPH
IMPACT ANGLE 34°
VEHICLE WEIGHT ... 17,500
(W/DUMMY & INSTRUMENTATION)

GUARDRAIL 36" Chain Link
fence w/ 3/4" cables 9" & 30" above pvt.
POST 2 1/4" - 4.1 #
H Section Fence Post.
POST SPACING 8' O.C.
LENGTH OF INSTALLATION ... 304'
GROUND CONDITION Dry

DUMMY INJURY Left shoulder injuries.
GUARDRAIL DAMAGE 90' of fence knocked out. No damage
to cables.
POST DAMAGE 23 Posts damaged beyond repair.
VEHICLE DAMAGE \$ 1200
MAX. DYNAMIC DEFLECTION OF RAIL ... 12"
DUMMY DECELERATION (PEAK) Long. 2.8 G .. Transv. 9.3 G

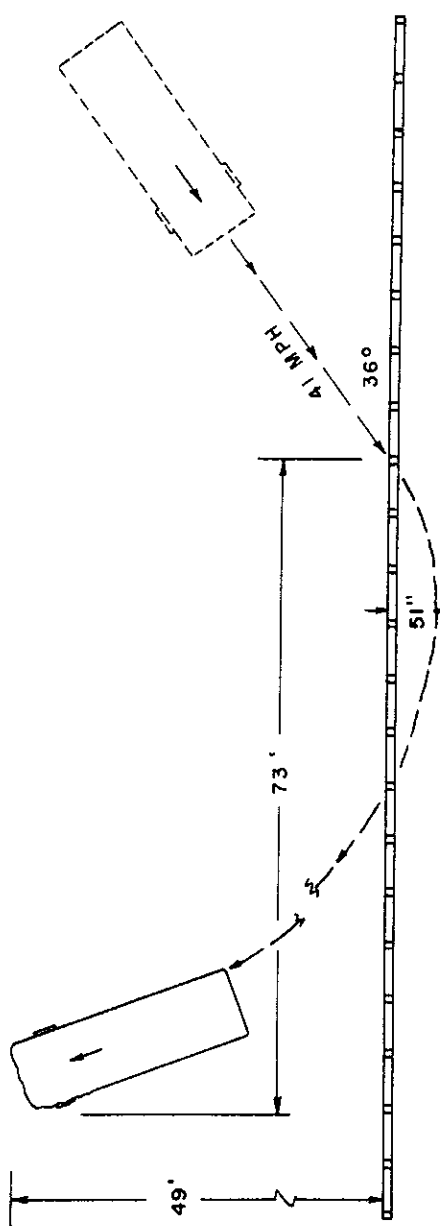
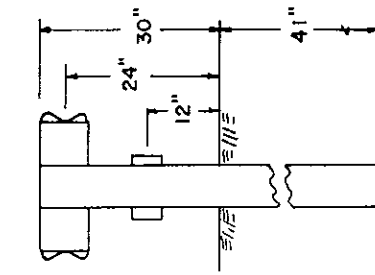
GUARDRAIL	W Section	DUMMY INJURY	Critical head, neck & shoulder injuries; severe body bruises.	TEST NO.	24
CHANNEL	6" x 8.2 #	GUARDRAIL DAMAGE	7 Sections damaged beyond repair.	DATE	4-30-59
BRACKET	8x8x12 D.F. Block	CHANNEL DAMAGE	4 Damaged beyond repair.	VEHICLE	1937-40 pass. Bus.
POST	8 x 8 D.F.	POST DAMAGE	5 Damaged beyond repair.	SPEED	41 MPH
POST SPACING	6'-3" O.C.	VEHICLE DAMAGE	\$ 1,500	IMPACT ANGLE	36°
LENGTH OF INSTALLATION	125'	MAX. DYNAMIC DEFLECTION OF RAIL	58"	VEHICLE WEIGHT	17,500
GROUND CONDITION	Dry	DUMMY DECELERATION (PEAK)	Long. 6G ... Transv. 25 G	(W/DUMMY INSTRUMENTATION)

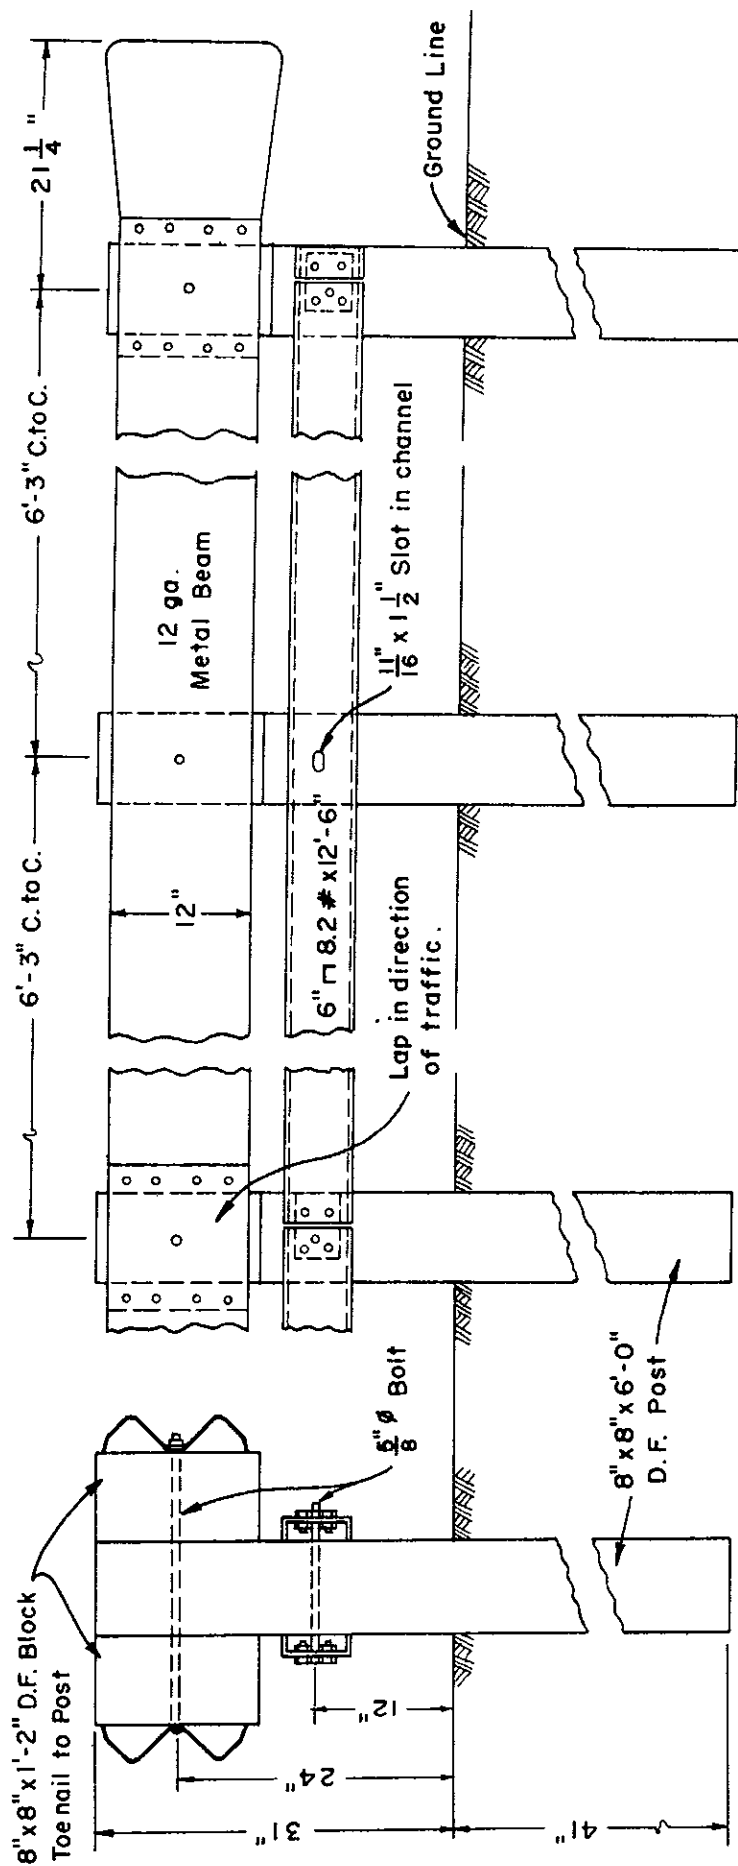
BLOCKED OUT METAL BEAM BARRIER

The Blocked Out Metal Beam Barrier design shown in Exhibit 23 is the most effective for narrow medians and traffic conditions where deflections allowed by the cable-chain link type could not be tolerated. During the tests this barrier satisfied all three criteria to some degree.

The two designs shown on Exhibits 22 and 23 are recommended for use as traffic barriers between divided roadways subject to the following:
